**CERCLA  
COMBINED ASSESSMENT REPORT**

**Morris Paints and Varnish  
East St. Louis, Illinois  
ILD 096721063**

**PREPARED BY:  
ILLINOIS ENVIRONMENTAL PROTECTION AGENCY  
BUREAU OF LAND  
DIVISION OF REMEDIATION MANAGEMENT  
OFFICE OF SITE EVALUATION**

**3  
SEPTEMBER 2002**

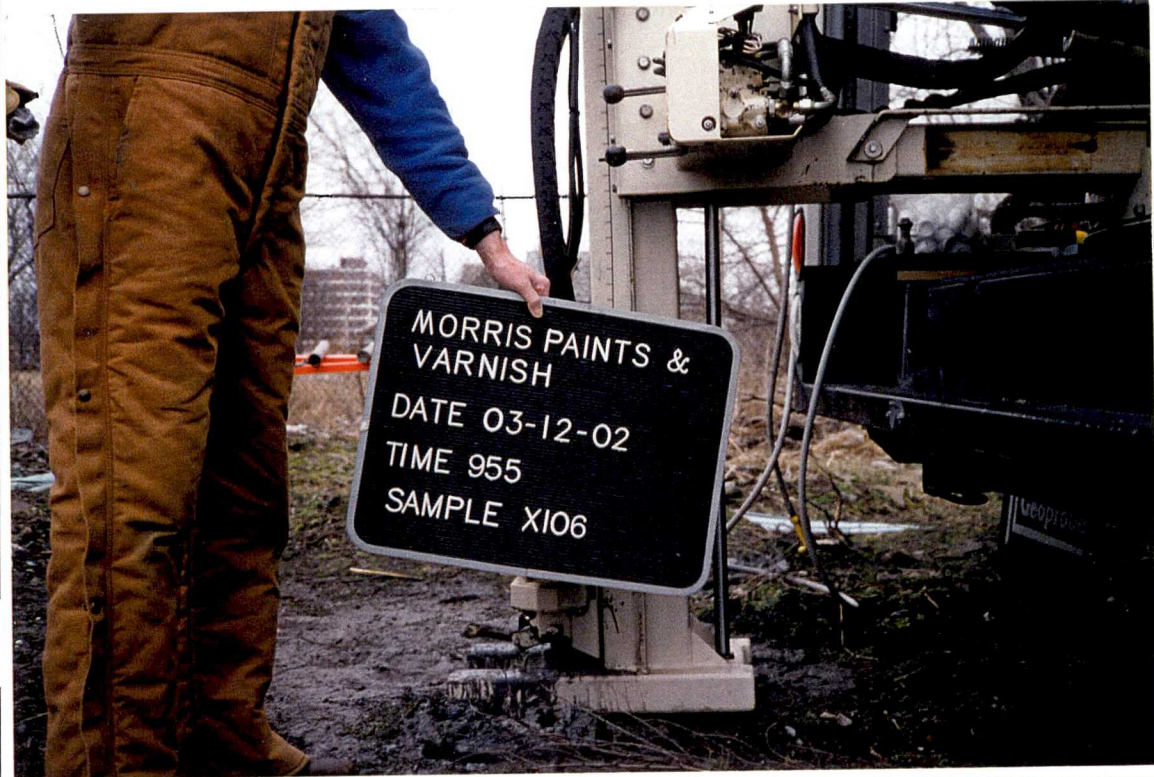
PHOTOGRAPH TAKEN BY: R. Casper
COMMENTS: Picture taken toward: North-northeast
Photo Number 1.
Sample X106 was collected onsite in the northwest area of the property.

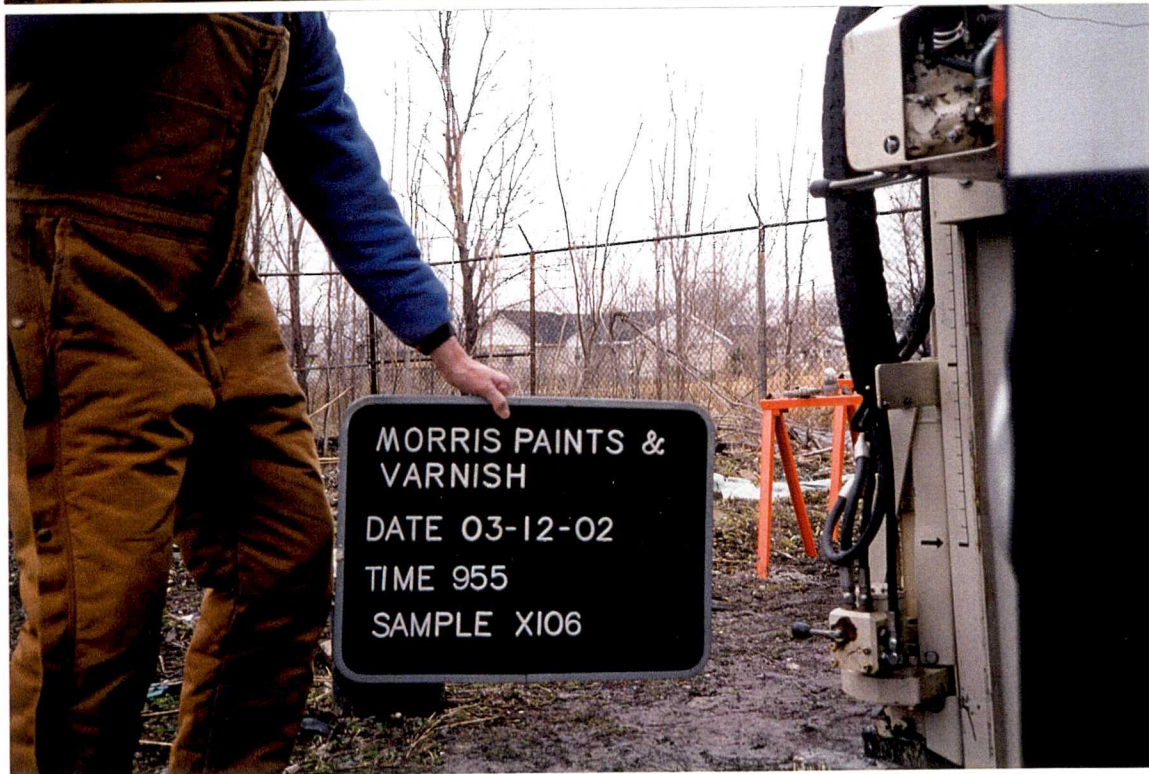
DATE: 3-12-02
TIME: 9:55
PHOTOGRAPH TAKEN BY: R. CASPER
COMMENTS: Picture taken toward: North.
Photo Number 2.
Sample X106. The sample was collect- ed with the Geo- Probe at a depth of 7 to 8 feet.

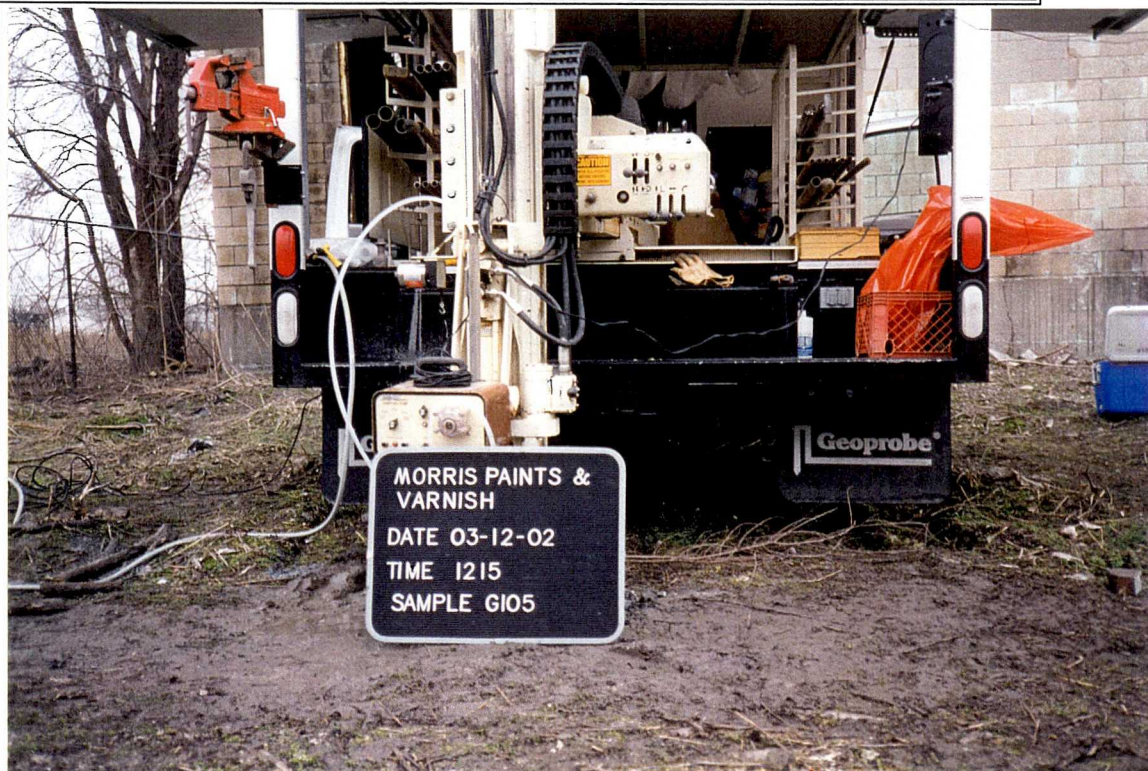
Photo Number 3.

Sample G105 was  
collected onsite  
at the same loca-  
tion as X106. Hit  
water at 22.5 feet

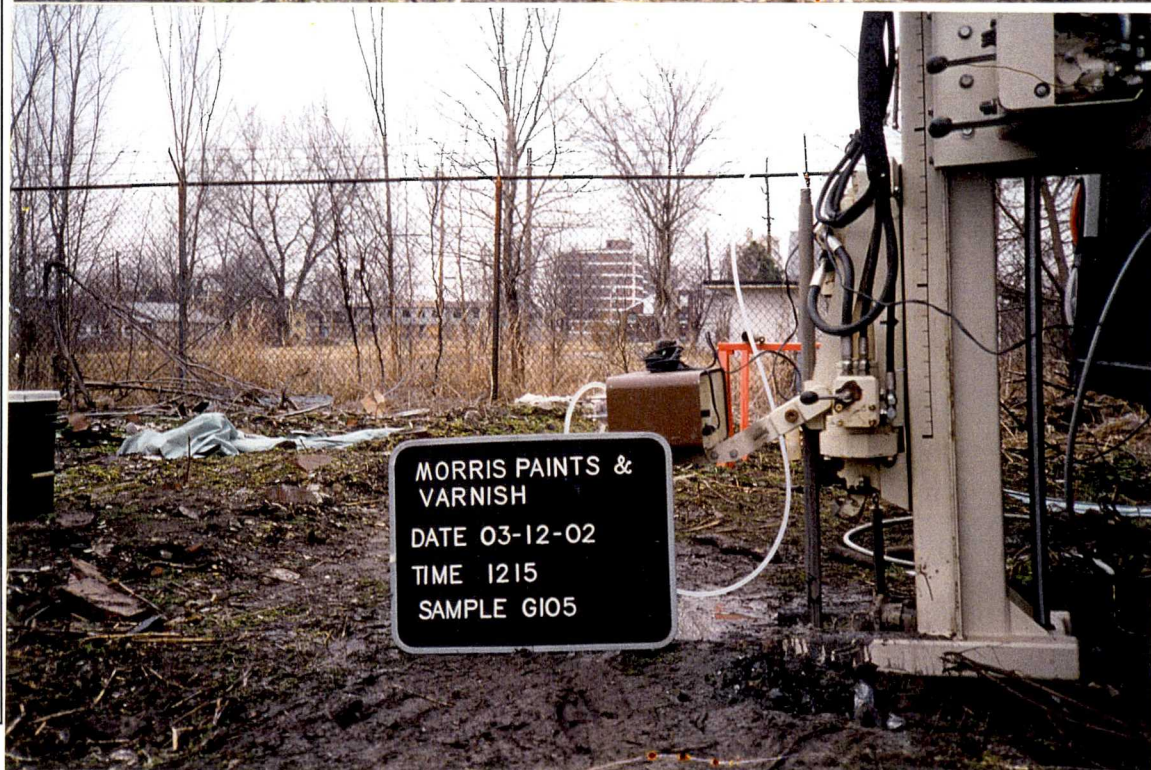
Photo Number 4.

Sample G105. The  
sample was collect-  
ed at a screened  
interval of 22 to  
26 feet.

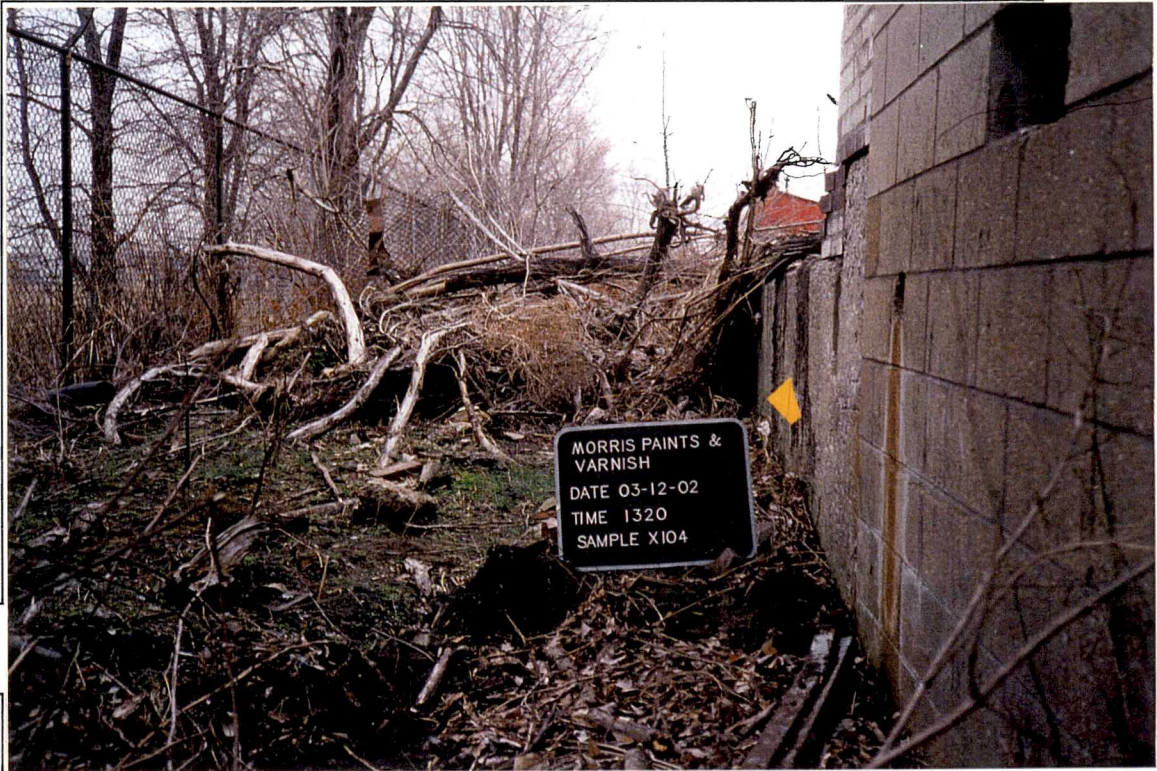
Photo Number 5.

X104 3/12/02 13:20	VOA - 6" BNA/Pest/PCB - 3" - 6" Inorg - 3" - 6"	Collected at the north side of the property next to the north side of the building foundation.	0 to 2' - Brown sand & fill material.
X105 3/13/02 16:00	VOA - 12" BNA/Pest-PCB - 6" to 12" Inorg - 0 to 4"	Collected neat the northeast corner of the property. Groundwater sample G104 also collected at this location.	0 to 6" - Black loam. some gravel. 6" to 3' - Black cinders, sandy black loam & gravel. 3' to 4' - Coal fines. 4' to 6' - Clayey brown sand. 6' to 7' - Sandy brown clay. 7' to 12' - Fine brown sand.
X106 3/12/02 9:55	VOA - 7-8' BNA/Pest/PCB - 7-8' Inorg - 7-8'	Collected at the northwest area of the property. Groundwater sample G105 also collected at this location.	0 to 1.0' - Grey silty loam.. 1.0' to 2.5' - Brown silty clay, with sand & gravel. 2.5' to 4.5' - Dark brown to black cindery clay fill material, moist at bottom. 4.5' to 7.0' - cindery black glass-like material. 7.0' to 11' - Grey/white paint waste. 11.0' to 12' - Fine grey sand. 12' to 26' - Fine grey sand; water at 22.5'

Sample X104 was  
collected onsite  
at the northeast  
area of the  
building.

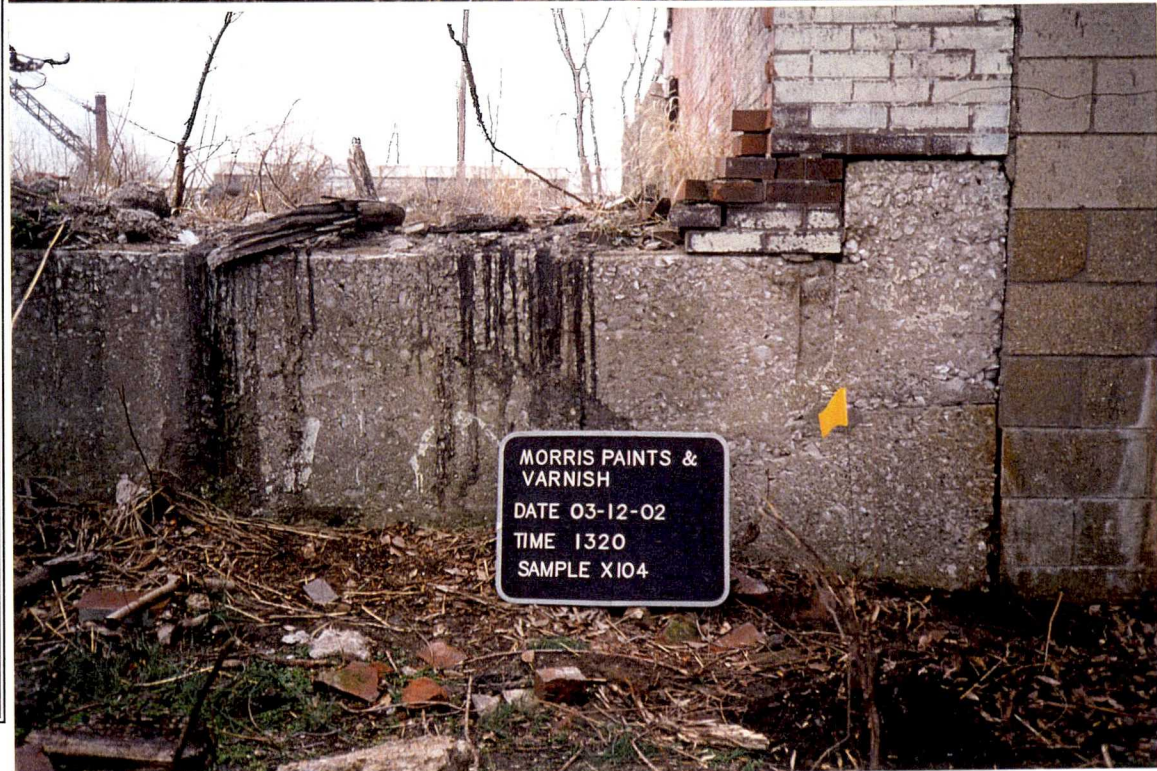
Photo Number 6.

Sample X104. The  
sample was collect-  
ed with a hand  
auger at a depth  
of 3 to 6 inches.

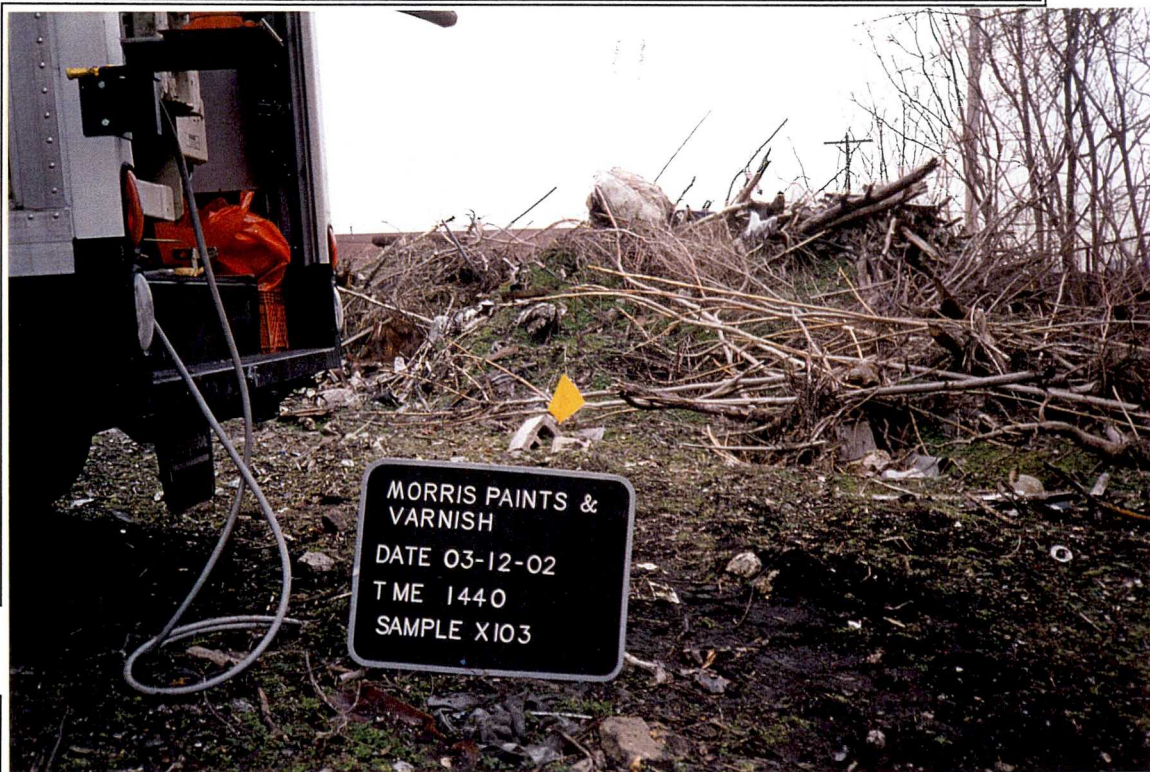
PHOTOGRAPH TAKEN BY: R. Casper
COMMENTS: Picture taken toward: South.
Photo Number 7.
Sample X103 was collected onsite in the southwest area of the property.

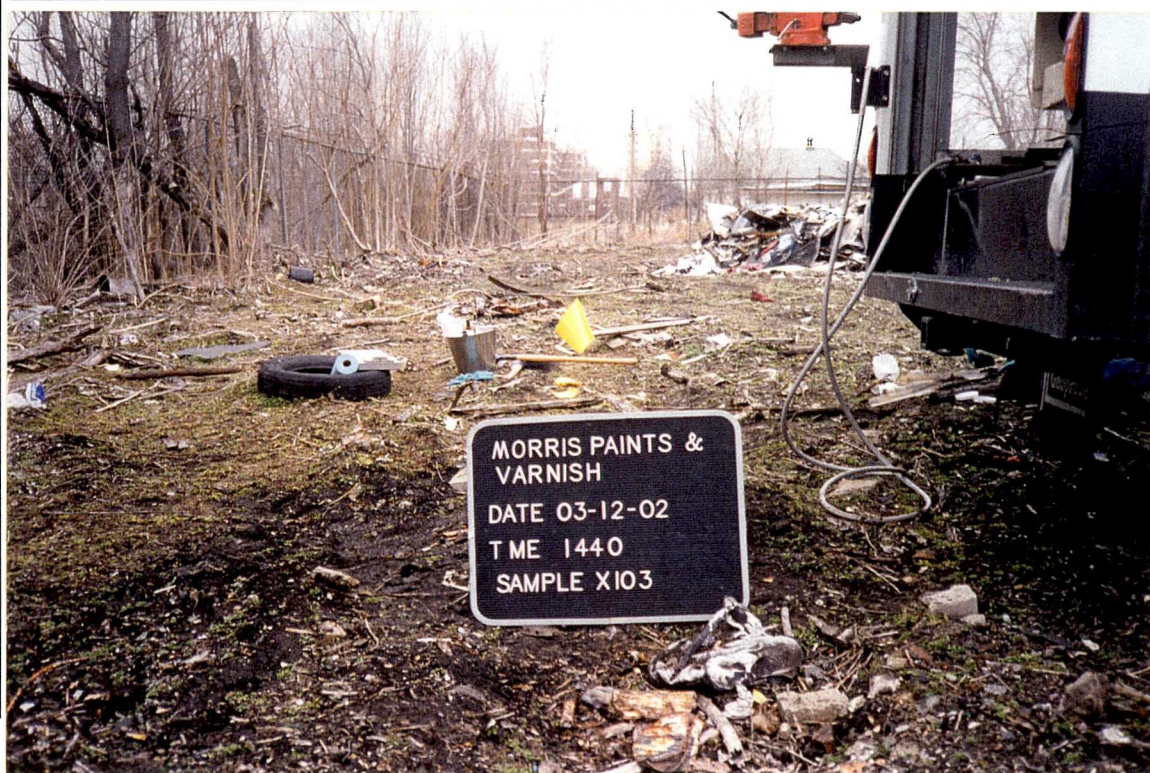
DATE: 3-12-02
TIME: 14:40
PHOTOGRAPH TAKEN BY: R. CASPER
COMMENTS: Picture taken toward: Northeast.
Photo Number 8.
Sample X103. The sample was collected with the Geo-Probe at a depth of 9 feet.

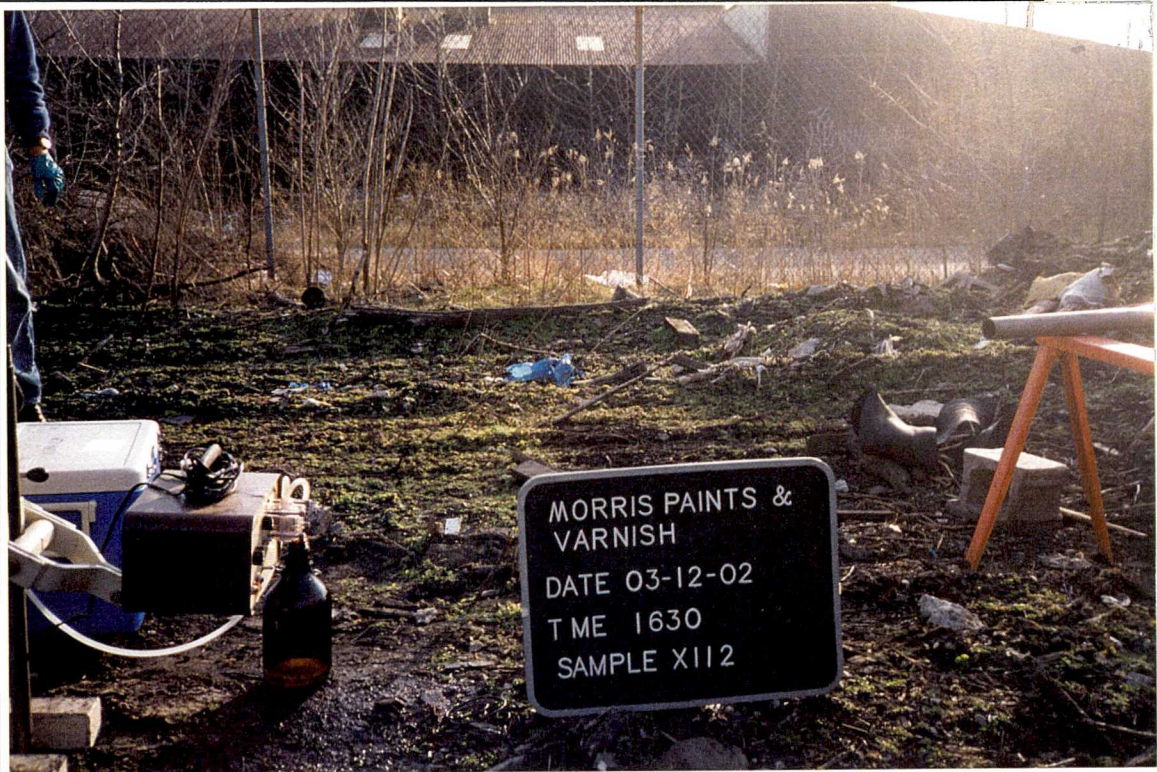
PHOTOGRAPH TAKEN BY: R. Casper
COMMENTS: Picture taken toward: Southwest.
Photo Number 9.
Sample X112 was collected onsite in the southwest area of the property.

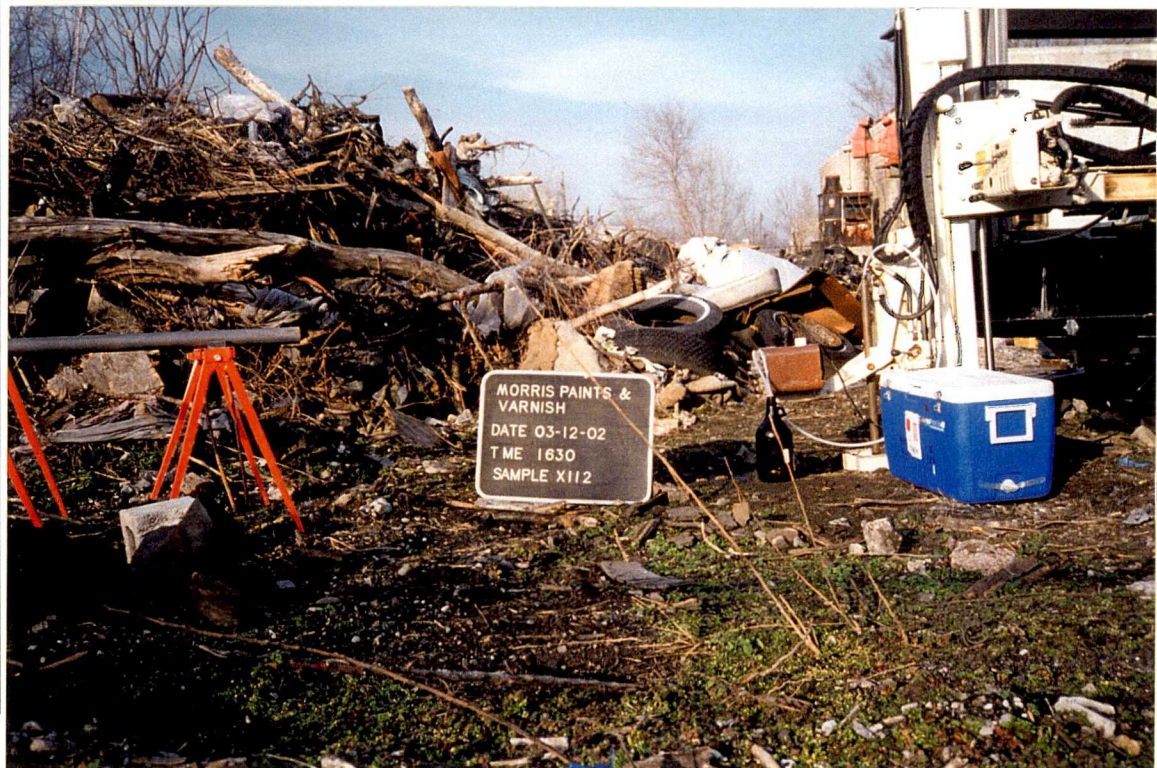
DATE: 3-12-02
TIME: 16:30
PHOTOGRAPH TAKEN BY: R. CASPER
COMMENTS: Picture taken toward: Northwest.
Photo Number 10.
Sample X112. The sample was collected with the Geo-Probe at a depth of 2 to 12 inches.

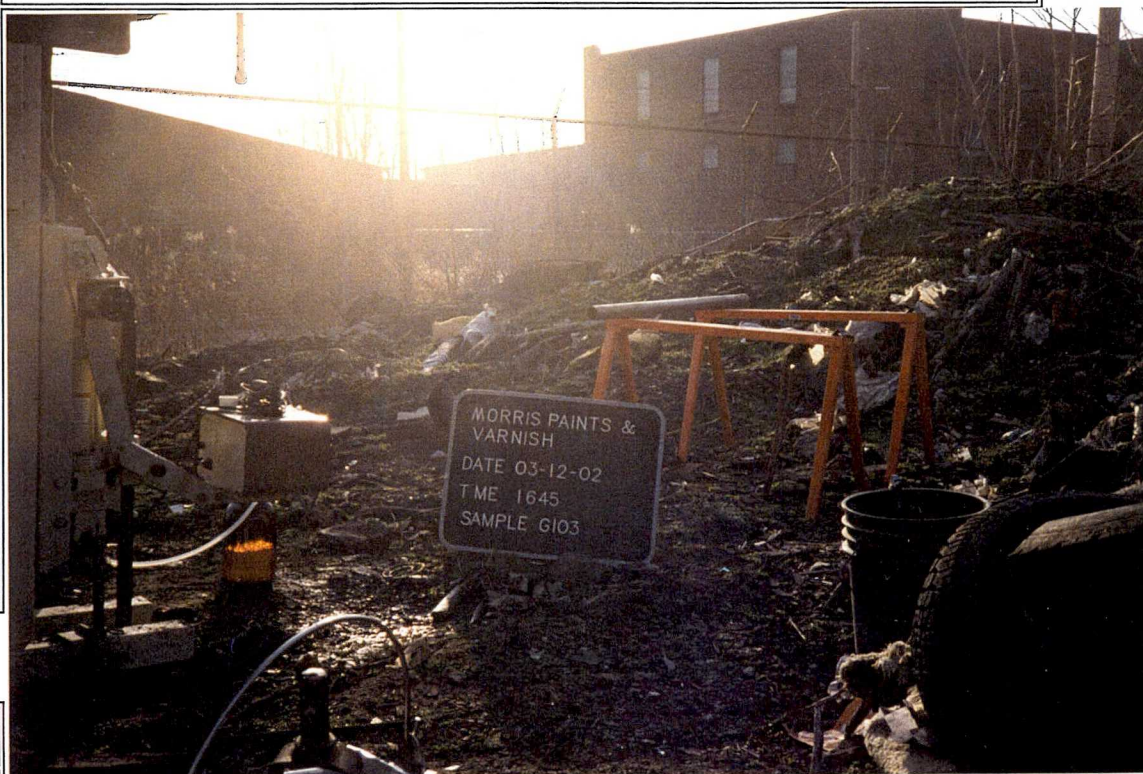
Photo Number 11

Sample G103 was  
collected onsite  
in the southeast  
area of the  
property.

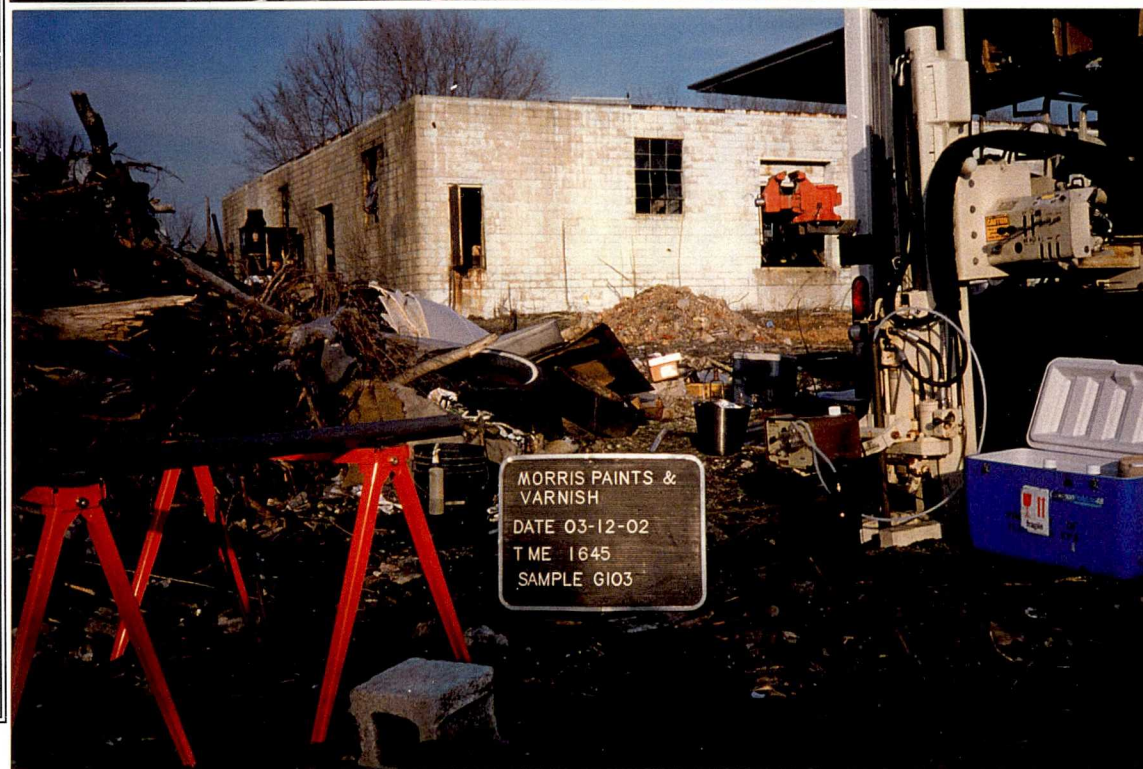
Photo Number 12.

Sample G103. The  
sample was collect-  
ed at the same  
location as X112,  
screened from 22  
to 26 feet.

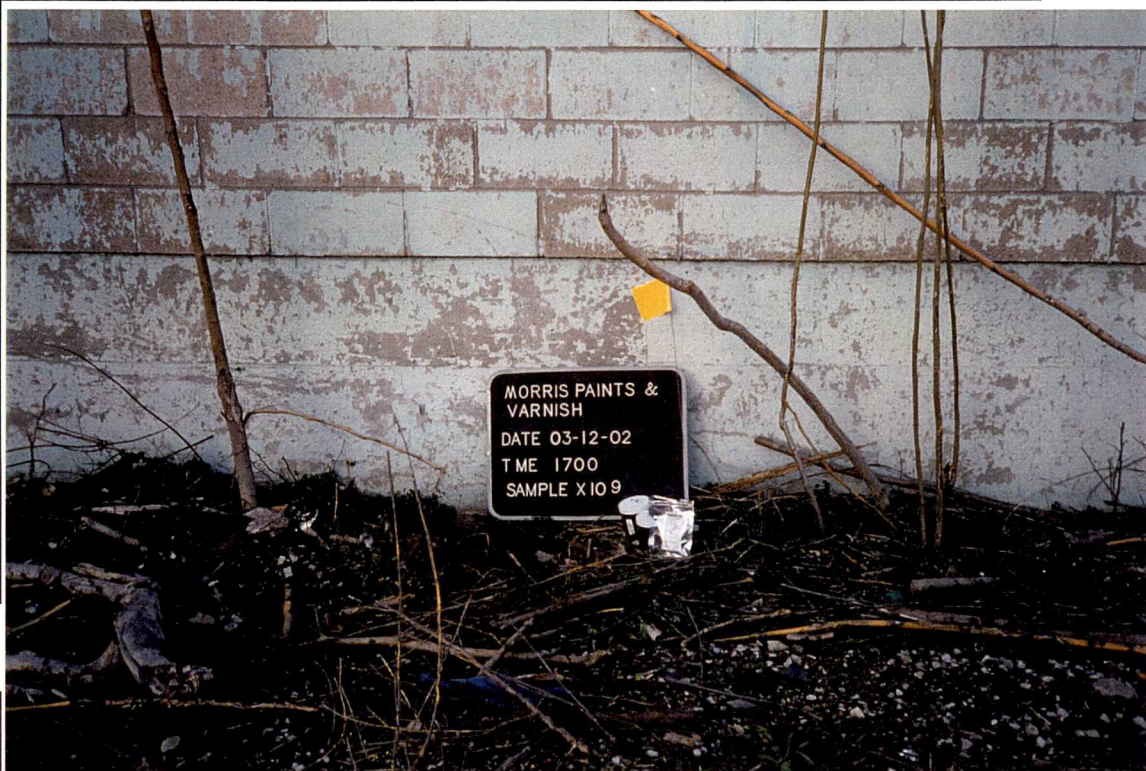
PHOTOGRAPH TAKEN BY: R. Casper
COMMENTS: Picture taken toward: Northeast.
Photo Number 13.
Sample X109 was collected onsite near the southwest corner of the building.

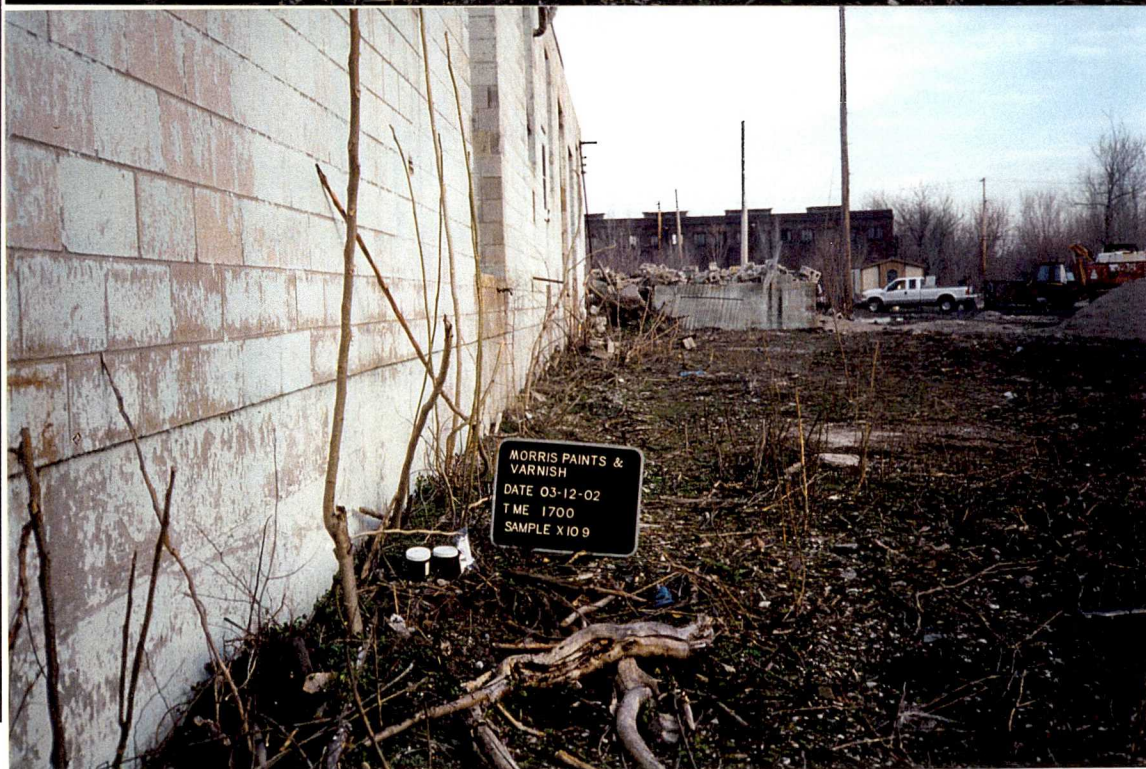
DATE: 3-12-02
TIME: 17:00
PHOTOGRAPH TAKEN BY: R. CASPER
COMMENTS: Picture taken toward: Southeast.
Photo Number 14.
Sample X109. The sample was collected with a hand auger at a depth of 2 to 12 inches.

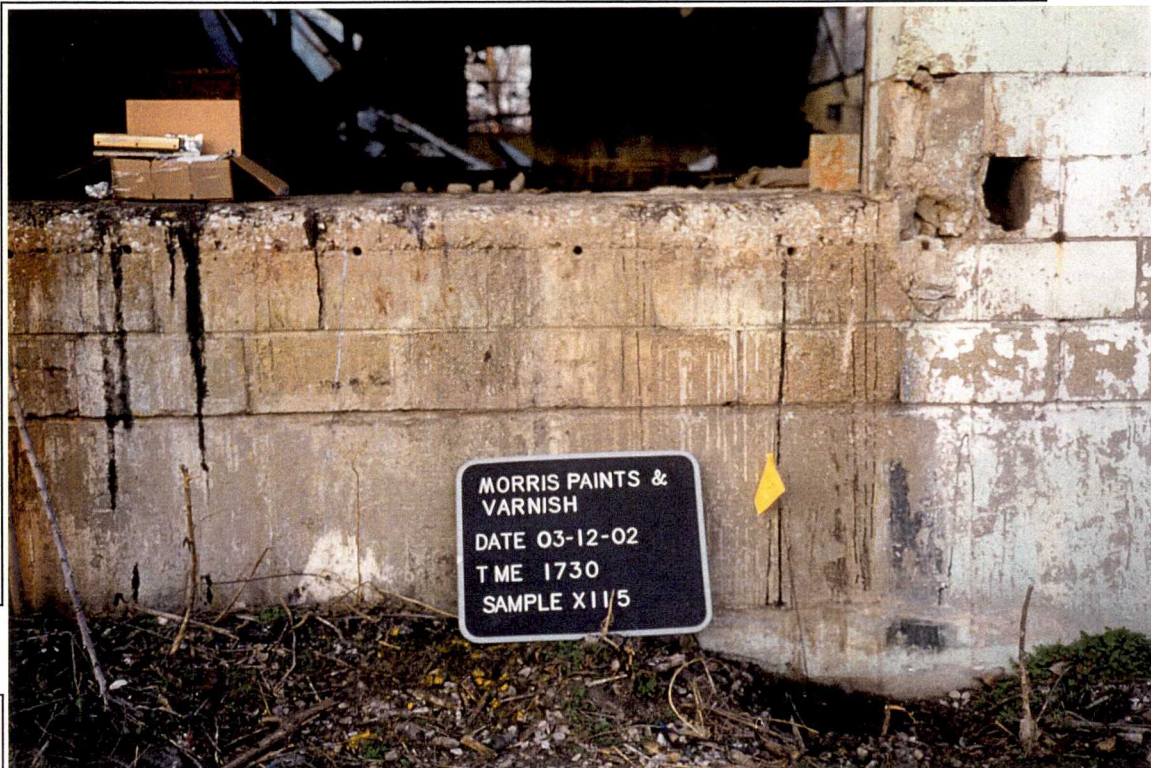
Photo Number 15.

Sample X115 was  
collected onsite  
at near the south-  
east corner of the  
building.

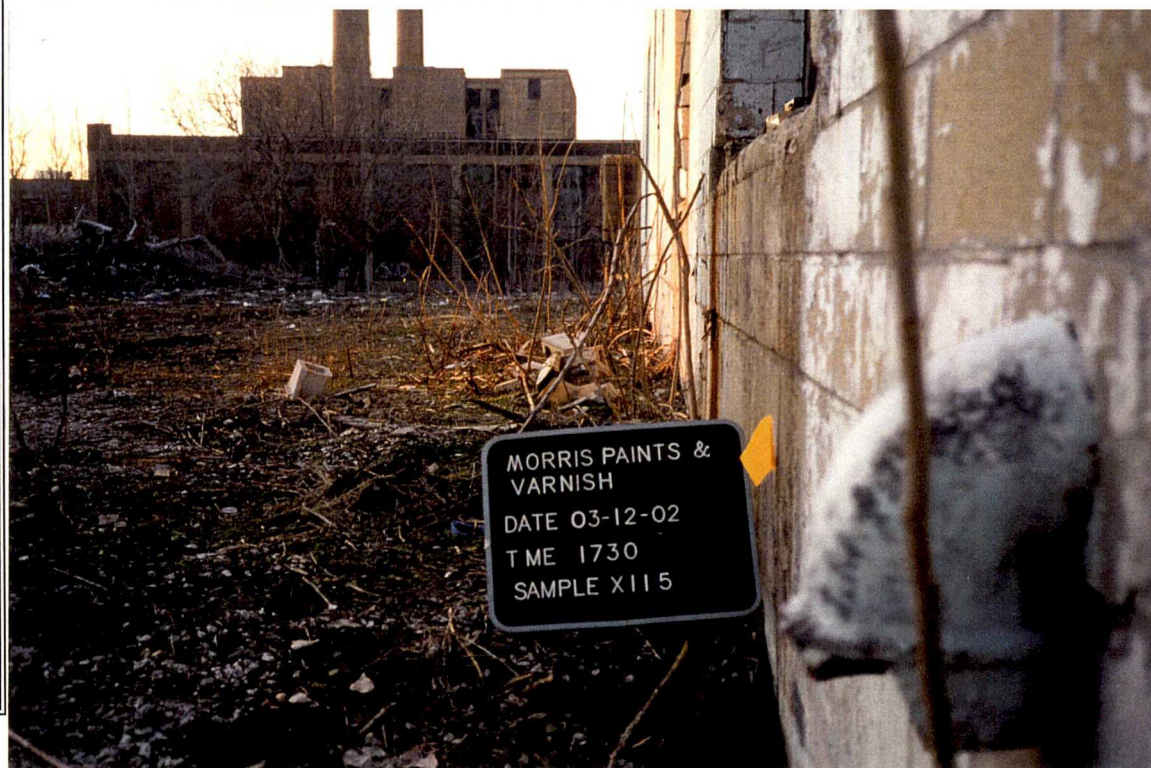
Photo Number 16.

Sample X115. The  
sample was collect-  
ed with a hand  
auger at a depth  
of 3 to 7 inches.

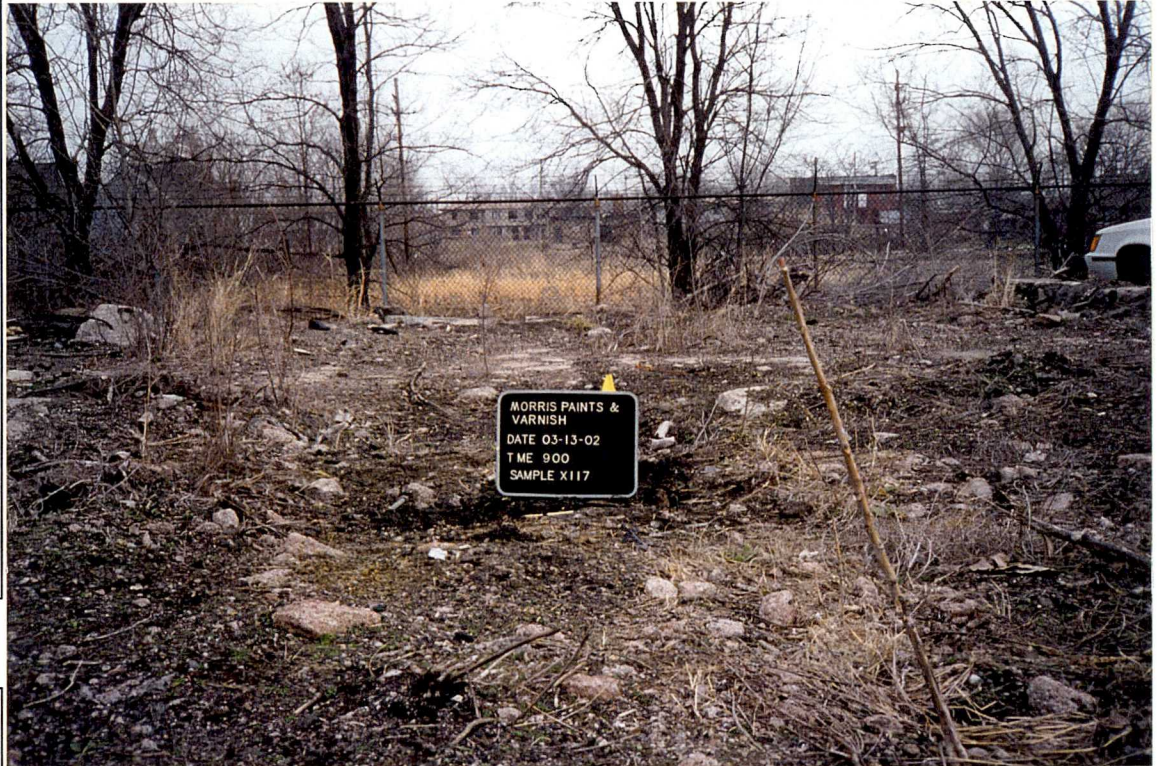
Photo Number 17.

Sample X117 was  
collected onsite  
at a broken spot  
on the concrete  
platform.

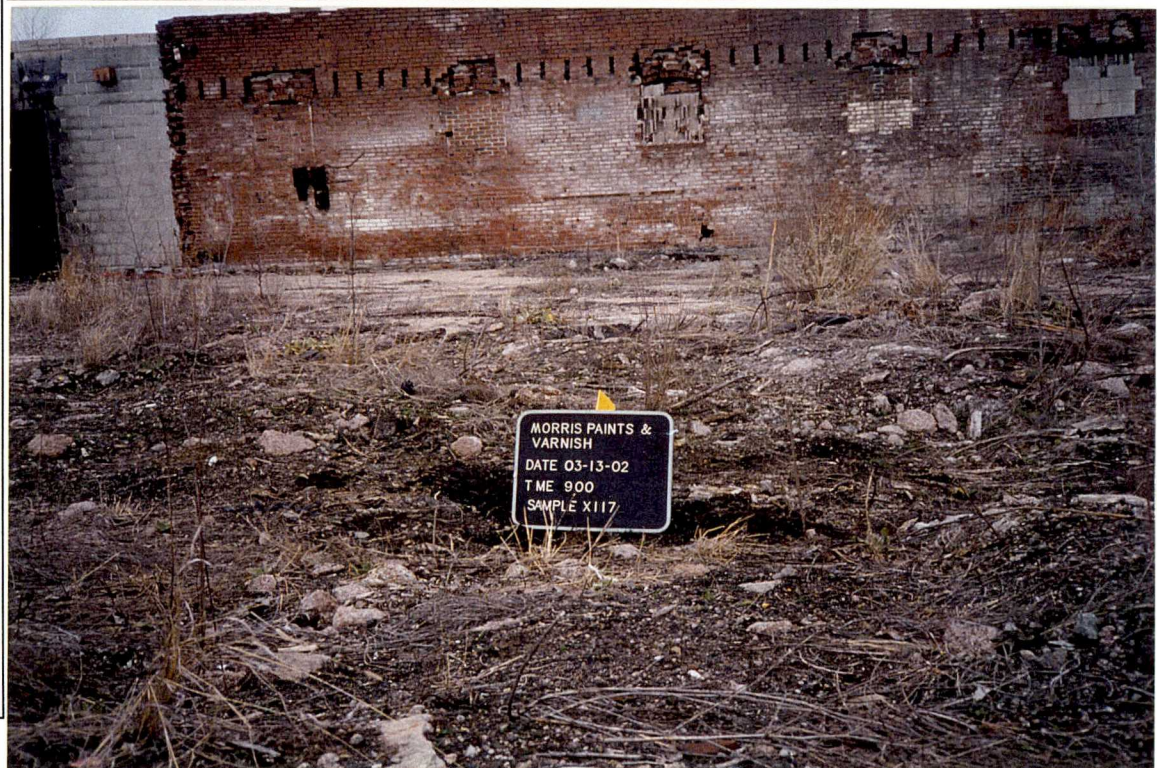
Photo Number 18.

Sample X117. The  
sample was collect-  
ed with a hand  
auger at a depth  
of 1 to 12 inches.

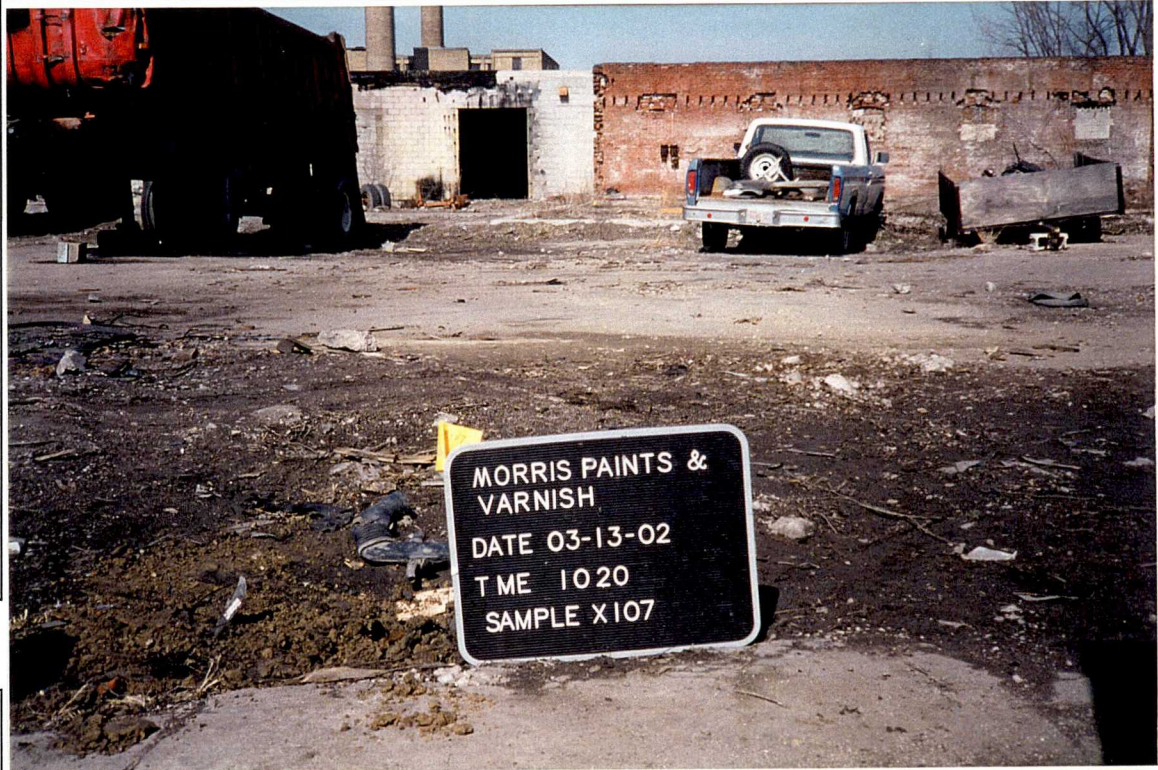
Photo Number 19.

X107 3/13/02 10:20 AM	VOA - 1' BNA/Pest/PCB - 1' Inorg. - 2.5'	Collected on concrete platform at site of former raw stock storage area. Concrete had breaks that allowed sampling.	0 to 1' - Brown clay & loam. 1' to 3' - Brown clayey loam.
X109 3/12/02 17:00	2" to 12"	Collected near the southwest side of the building, next to the building foundation.	0 to 2' - Black sandy loam.

Sample X107 was  
collected onsite  
at a break in the  
concrete platform.

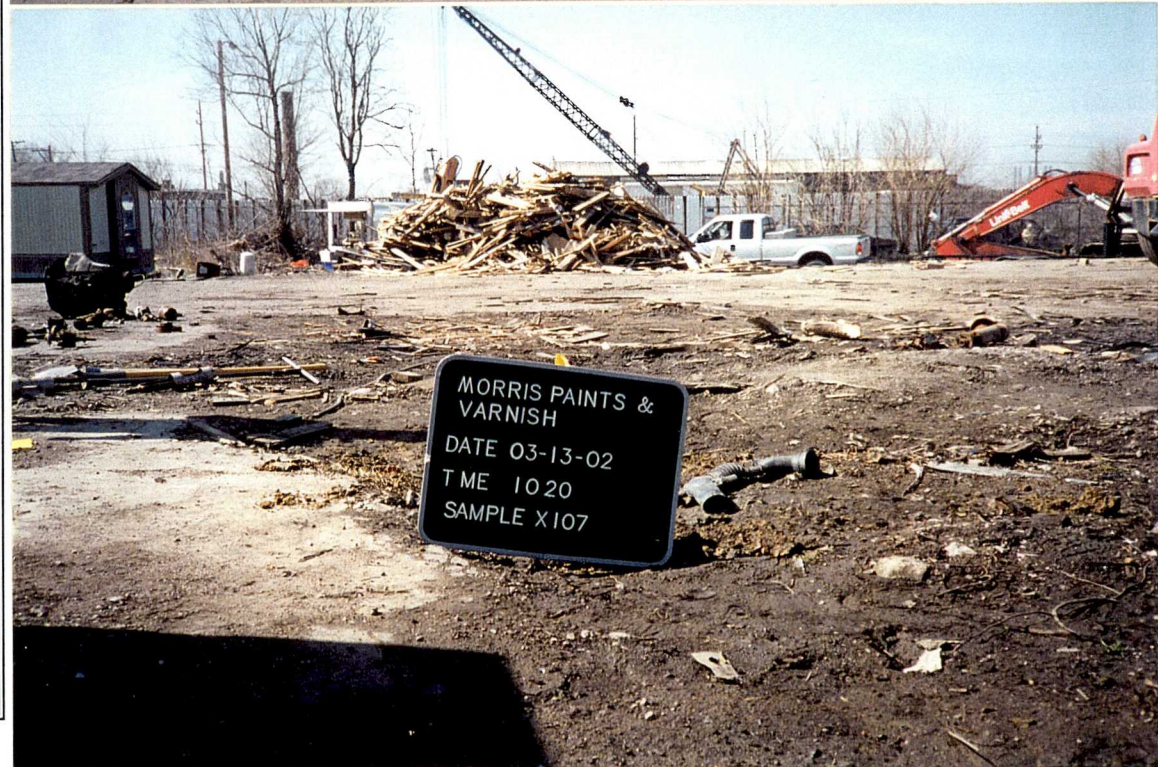
Photo Number 20.

Sample X107. The  
sample was collect-  
ed with a hand  
auger at a depth  
of 1 to 3 feet.

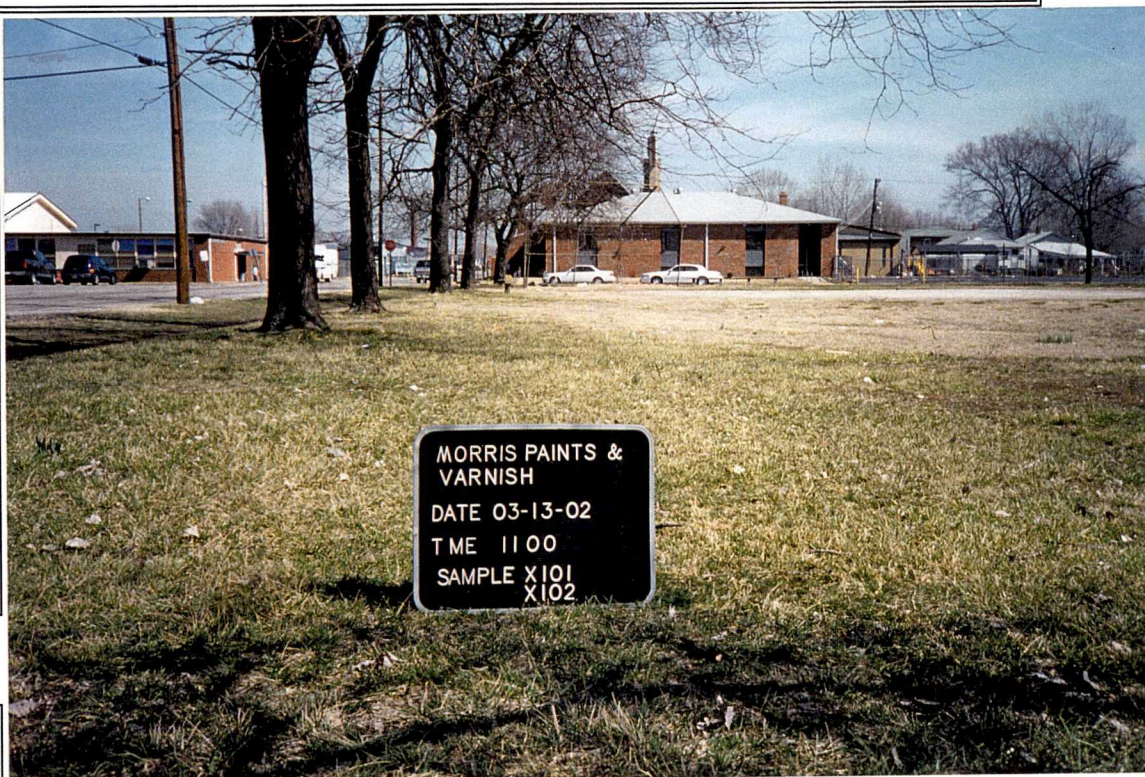
PHOTOGRAPH TAKEN BY: R. Casper
COMMENTS: Picture taken toward: Northeast.
Photo Number 21.
Samples X101/X102.
Sample and
duplicate sample
collected at a
depth of 1 to 2".

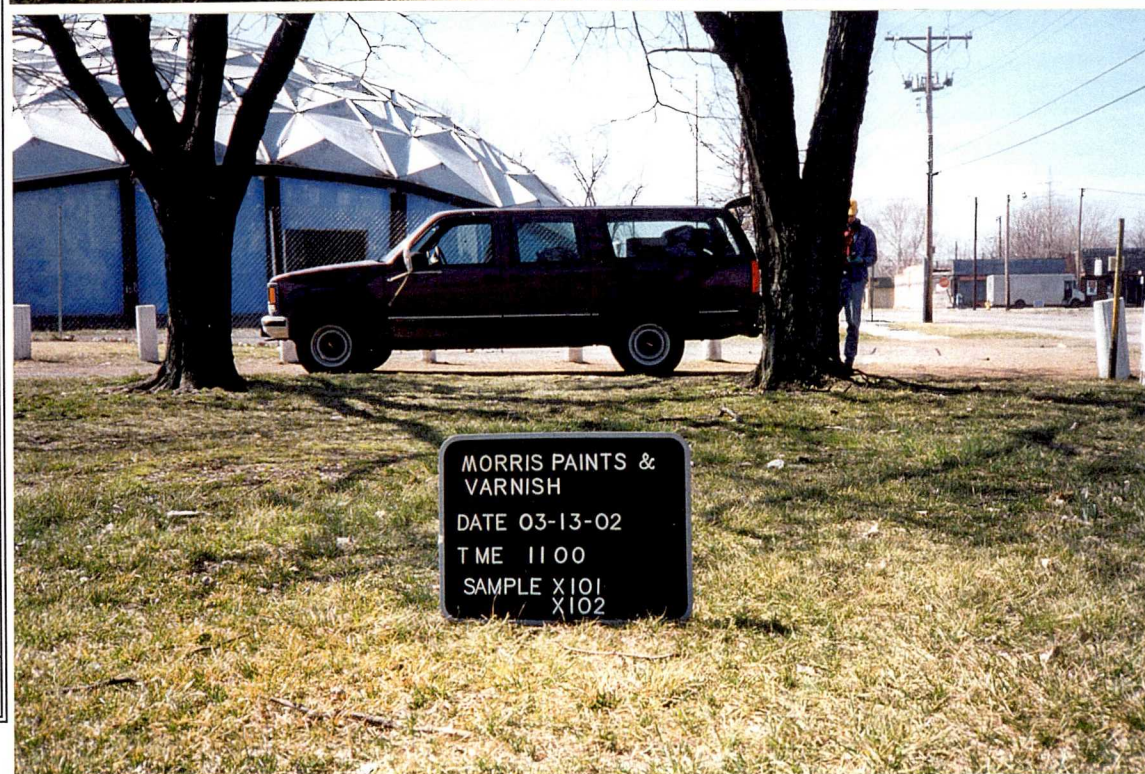
DATE: 3-13-02
TIME: 11:00
PHOTOGRAPH TAKEN BY: R. CASPER
COMMENTS: Picture taken toward: Southwest.
Photo Number 22.
Sample X101/X102.
Sample was collect-
ed at Lincoln Park
located approxi-
mately ¼ mile
south of site.

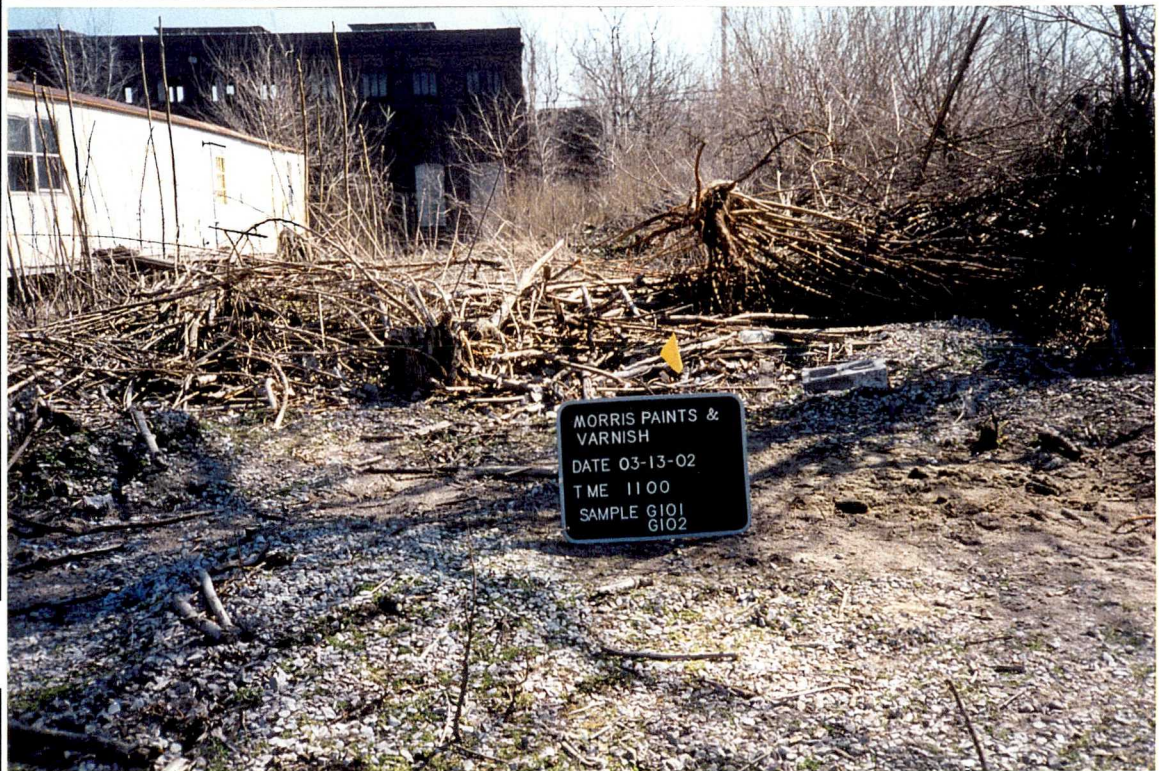
PHOTOGRAPH TAKEN BY: R. Casper
COMMENTS: Picture taken toward: Southeast.
Photo Number 23.
Samples G101/G102
were collected at
at the same
location as sample
X116.

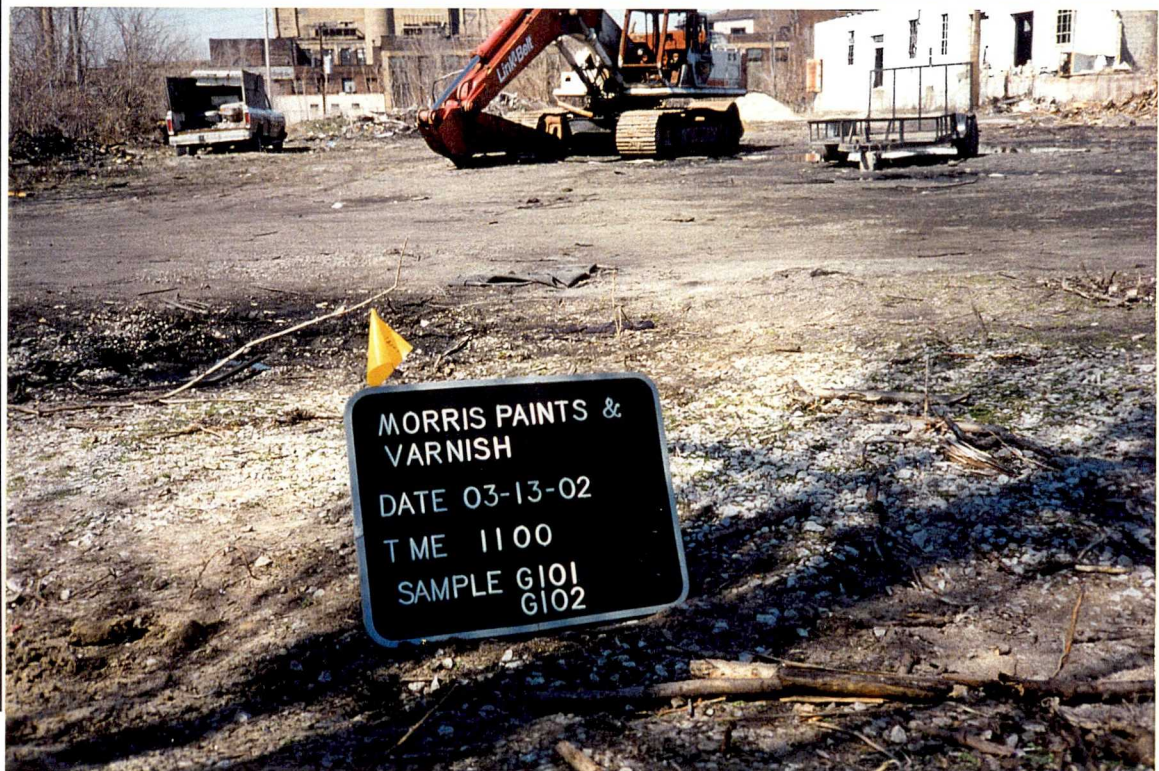
DATE: 3-13-02
TIME: 11:00
PHOTOGRAPH TAKEN BY: R. CASPER
COMMENTS: Picture taken toward: Northwest.
Photo Number 24.
Samples G101/G102.
sample was collect-
ed at screened
interval of 22 to
26 feet; water hit
: 22 feet.
